QUARTERLY UPDATE

FOR OCTOBER 1, 1993 THROUGH JANUARY 1, 1994

HISTORICAL RELEASE REPORT (HRR)

EG&G ROCKY FLATS, INC

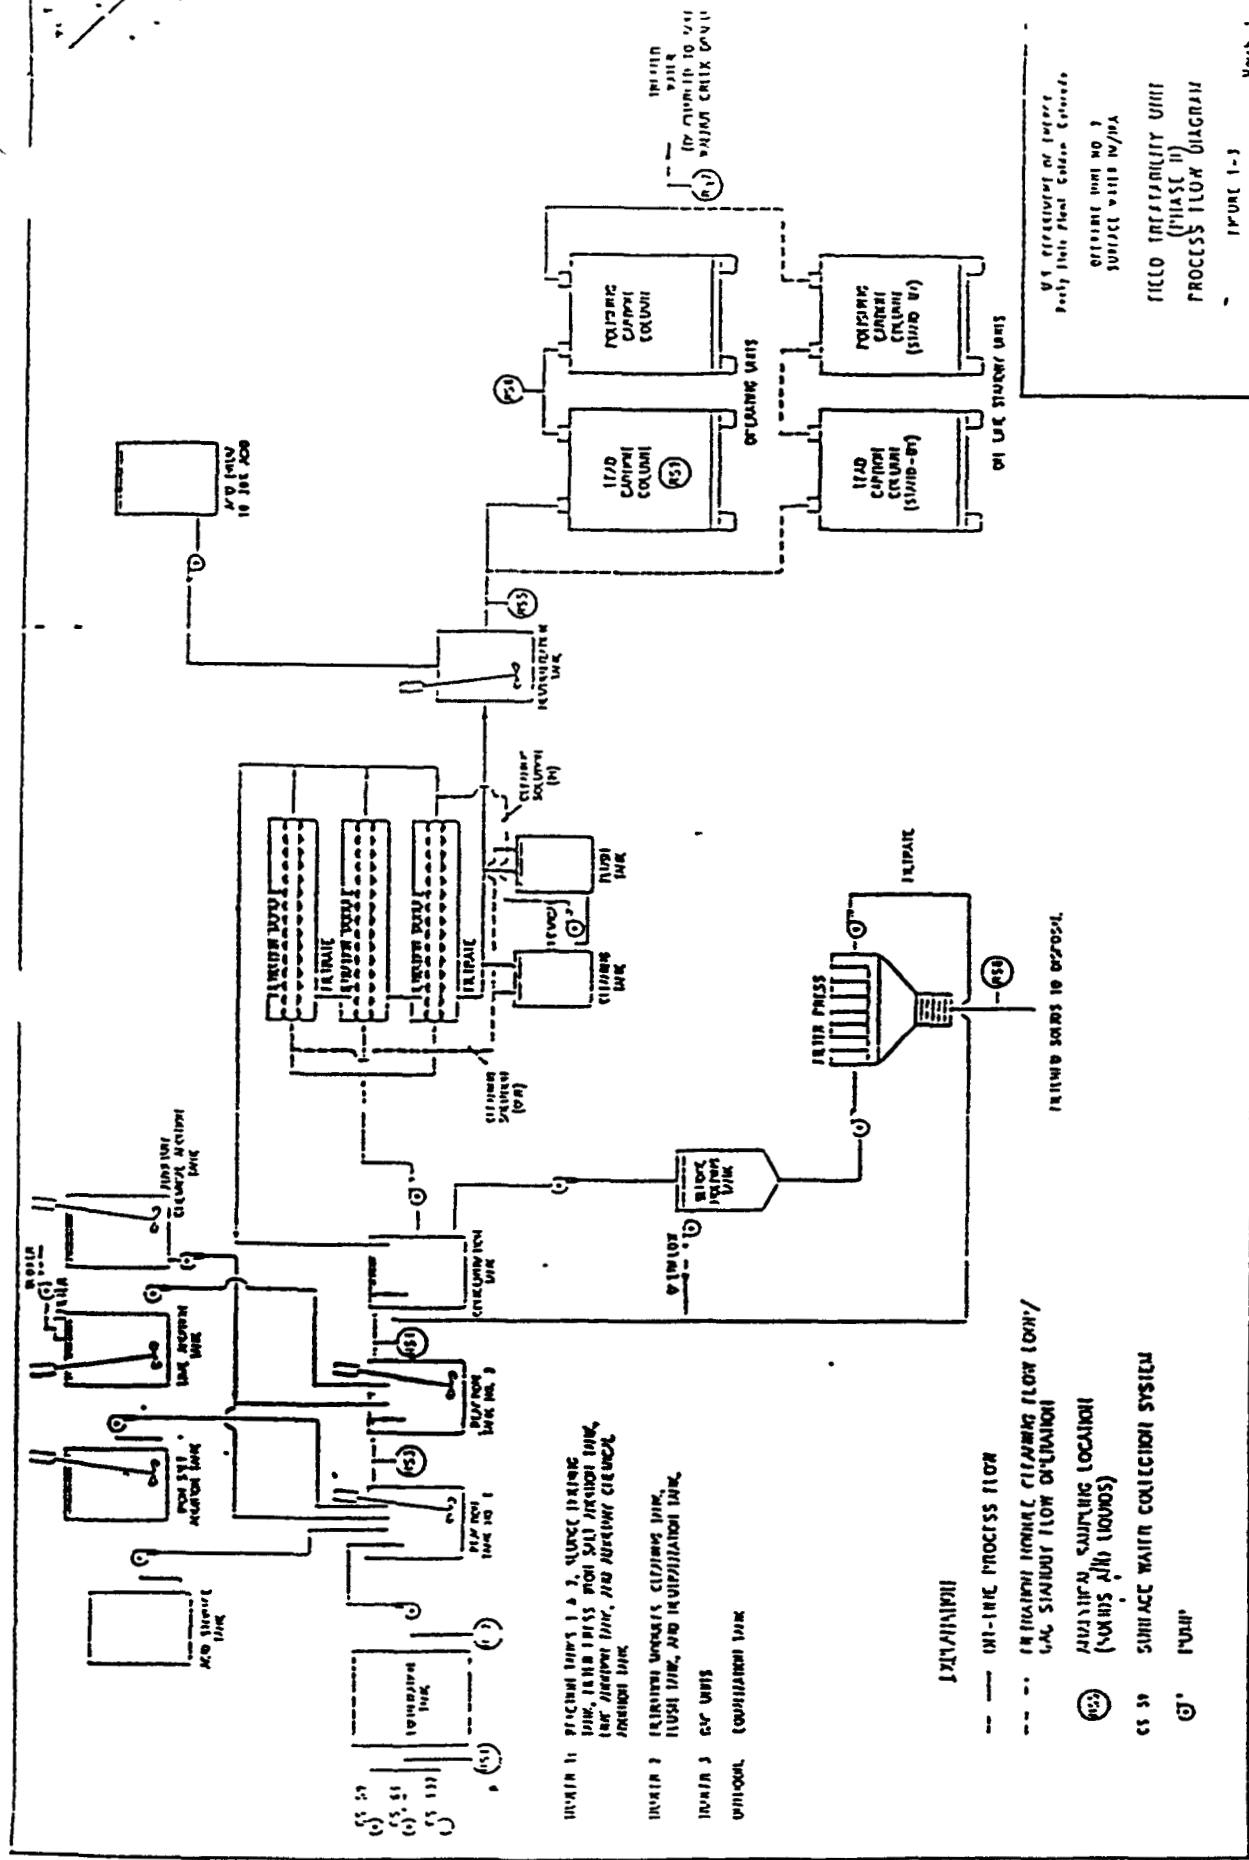
FIELD TREATABILITY UNIT PLOT PLAN
SOUTH WALNUT CREEK BASIN

A release of potentially contaminated water from an influent pipe system leading from Walnut Creek to the treatment system occurred due to a hole in the primary line. The release was discovered at 2:30 p.m. on Saturday, December 4, 1993. A subcontractor employee discovered the release from an influent water line in response to an alarm signaling that a release had occurred. The line in question has secondary containment. The line was found to be leaking due to a separation of two pipes that make up the secondary pipeline. The pumps were immediately shut down and contractor personnel visually inspected the line for a release. The point of the release was discovered under a road culvert.

X approx location of leak/spill

The pumps were de-energized immediately after the leak was discovered. Subcontractor personnel immediately began repairs on the pipe. An emergency work package was completed to temporarily repair the line. The incident was not reported to the Emergency Operations Center (EOC), or the Shift Superintendent (the Rocky Flats Plant RCRA Emergency Coordinator) at the time of the incident. A report was made to the EOC on Monday December 6, 1993, at approximately 4:30 pm. The pipeline was repaired and the system was back in operation on December 8, 1993. The pump was re-energized and the system was returned to normal operation. A letter has been written and will be sent to the responsible supervisors outlining release response and reporting requirements at the Rocky Flats Plant. Plans are being made to permanently replace the pipeline to minimize the likelihood of a recurrence of a release from this system.
